Identification of Coal Seams in North America Survey “Site A”

1.2 Data Processing – Workflow 4

1.3 Data Analysis – Coal Seam Identification

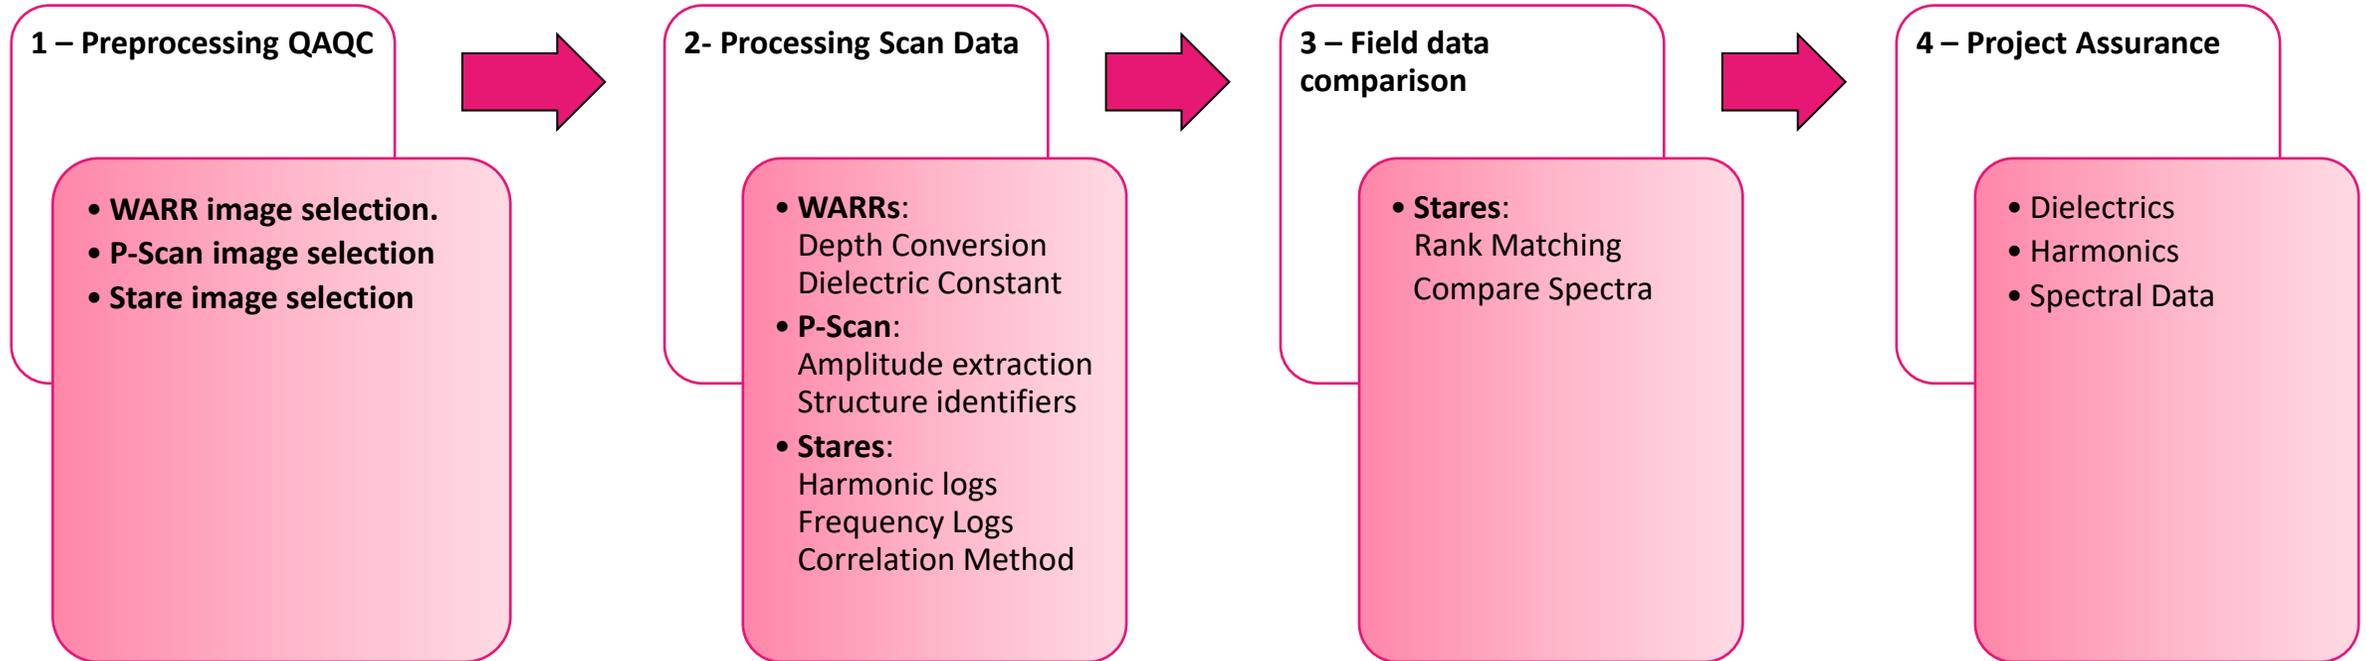
🌈 Each work package was processing by using the same tools and procedures within the workflows.

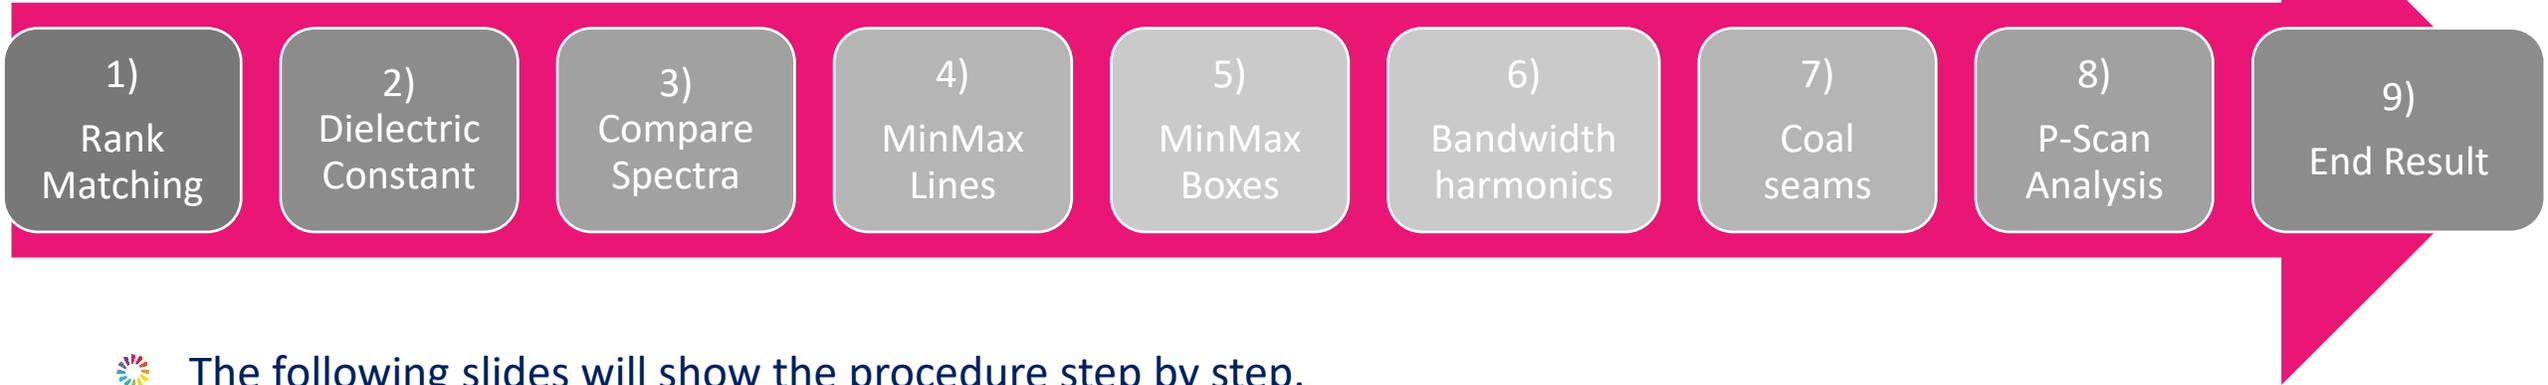
- This method uses several sources of processed data to identify distinct lithological zones in the V-Bore.
- The following slides will display the results of the zonation for the stare data based on:

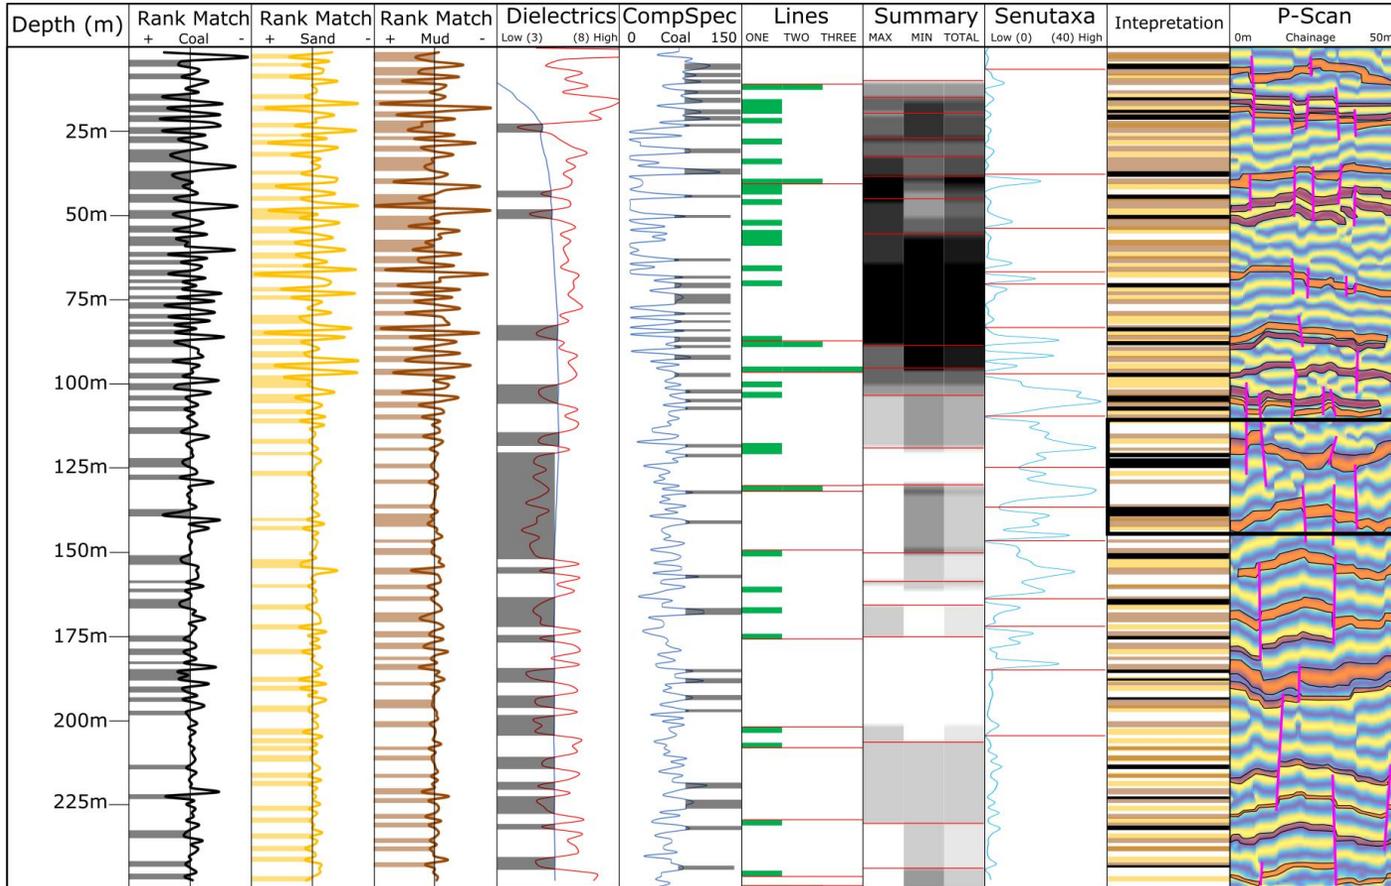
8) P-Scan Analysis

- Coal
- Sandstone
- Mudstone

Potential faults and fractures are marked with a bright pink.

The P-Scan is interpreted by following the reflectors that correspond to the coal seams interpreted, those reflectors are marked with red and outlined.

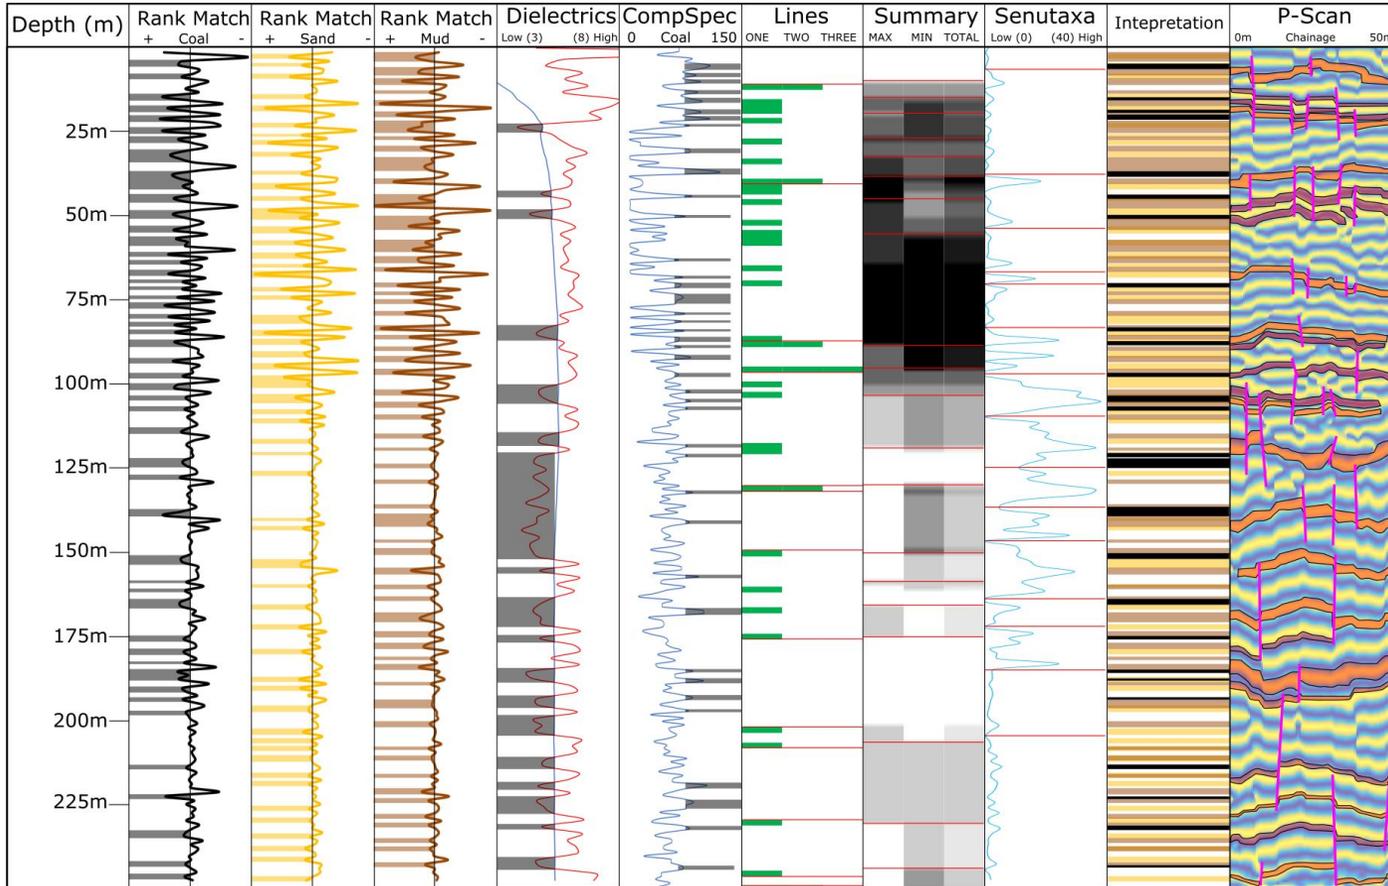
9) End Result

Coal
 Sandstone
 Mudstone

To complete the process, the ADR Zones are coloured based on equivalent Training Data. In this case, using the petrophysical interpretation of the downhole logs.

- The next slide shows a very detailed breakdown of the behaviour of each of the 5 parameters within each of the 15 detected ADR Zones.
- For the blind holes, the relationships between the ADR Zones and the petrophysical established in this training zones will be used to define the lithology of the ADR Zones.
